4.0 PHIL'S AUTO SITE – 701 ISLETA BOULEVARD, SW NMED Facility Number 5517001

4.1 INTRODUCTION/SITE HISTORY

Soil and Groundwater Quality Summary Map

Phil's Auto Site
701 Isleta Blvd., SW
Albuquerque, New Mexico

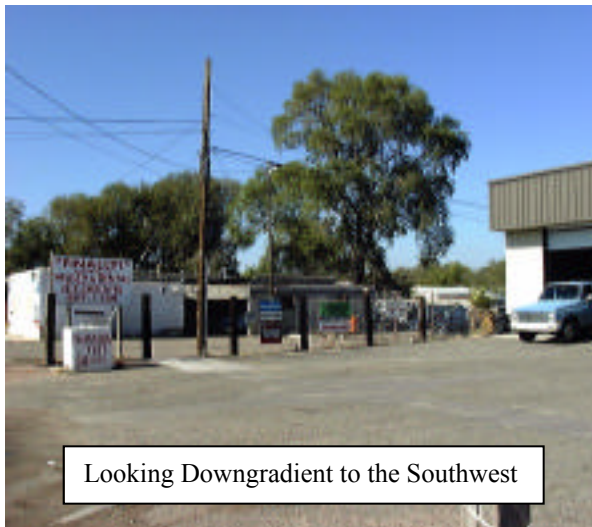
during which seven new monitor wells and five boreholes were advanced and sampled at the Site. Their investigations documented a southwesterly trending groundwater BTEX contaminant plume extending several hundred feet off-site. Unfortunately, during their investigations, TPH soil data was not collected in any of the drilling locations and no boreholes or wells were installed in the tank pit area. The magnitude and extent of the soil contaminant plume was not characterized to the west, north, east or southeast (Figure 4A).
